Inspection Report

Property Address:
276 Phoenix Drive
Lawrenceville, GA 30044

Date:
July 15, 2011

Inspector:
Charles Mann
Edifice Inspections, Inc.
(770) 594-2222
www.edificeinspections.com

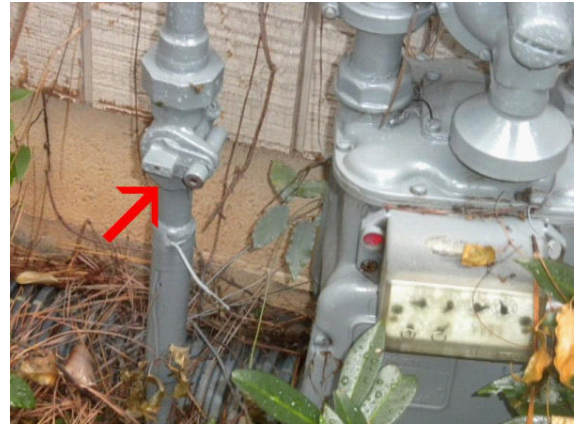
WATER SOURCE: Public.
SEWAGE DISPOSAL: Public.
UTILITIES STATUS: Gas service was off at time of inspection.

Gas meter was off

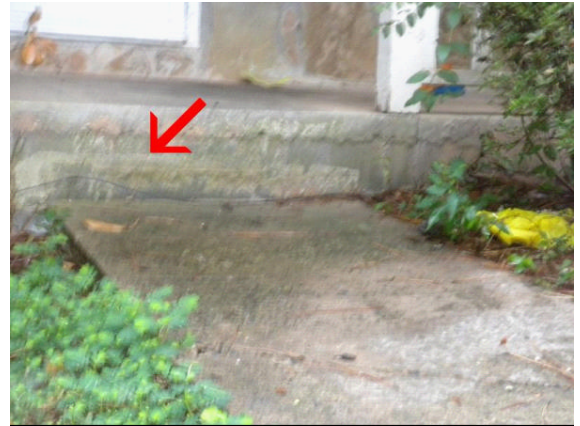
CONDITION: The front walkway has sunk/displaced vertically where it meets the front stoop. This makes the step between the walkway and stoop too high and a tripping hazard. Repairs should be made by a qualified contractor.

Walkway has displaced vertically

1. The front walkway has sunk/displaced vertically where it meets the front stoop. This makes the step between the walkway and stoop too high and a tripping hazard.

Repairs should be made by a qualified contractor.

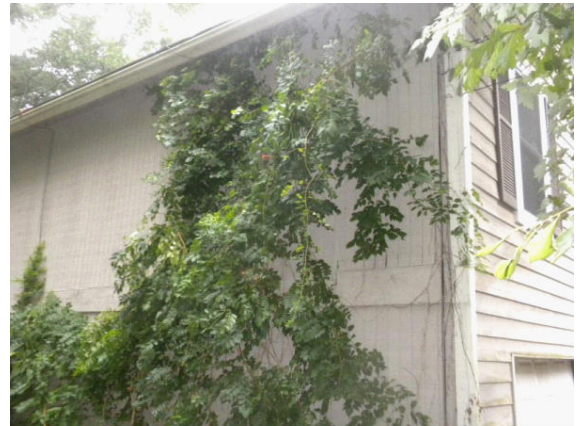
CONDITION: There are trees/bushes in contact with the house. Trimming of all trees/bushes away from the house is recommended to avoid damage to siding, trim or roofing.

Vines/bushes growing on the house

1. There are trees/bushes in contact with the house. Trimming of all trees/bushes away from the house is recommended to avoid damage to siding, trim or roofing.

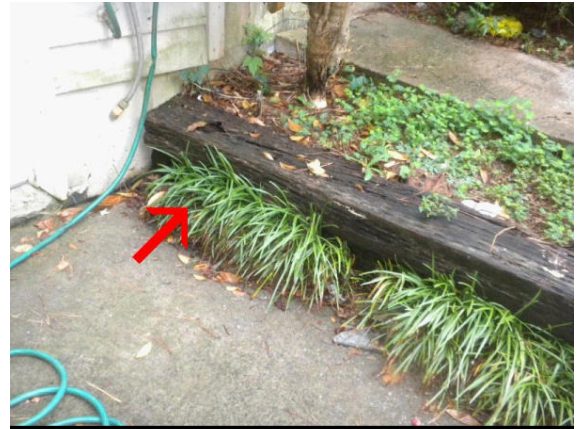
**Replace railroad ties**

2. The railroad tie retaining wall next to the garage is deteriorated and should be replaced. This is a small wall and will be inexpensive.

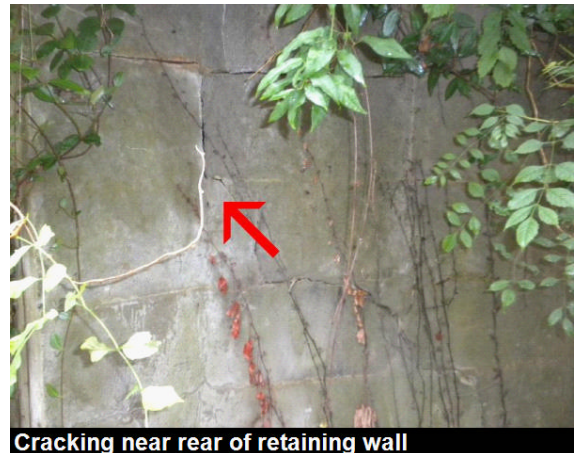
**Cracking near rear of retaining wall**

The concrete block retaining wall at the front left corner of the garage has cracked and displaced severely. Replacement of the wall will be needed in the near future. This will be an expensive wall to replaced due to its height and size.

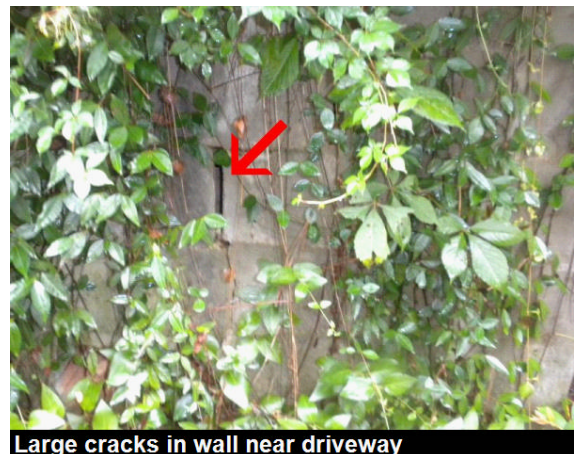
**Large cracks in wall near driveway****GRADING & SURFACE DRAINAGE:**

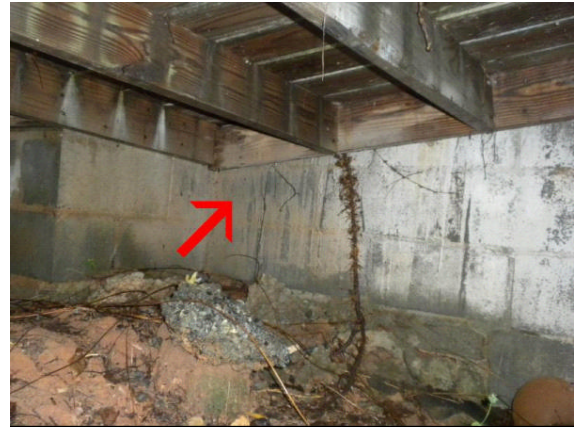
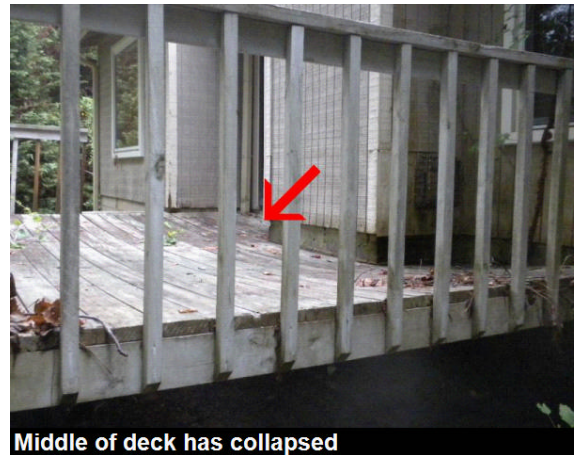
The deck has collapsed in its center resulting in a total deck failure. Removal and replacement of the entire deck is needed. Repairs should be made by a qualified general contractor.

Frame of deck has collapsed

Middle of deck has collapsed

3. The deck has collapsed in its center resulting in a total deck failure. Removal and replacement of the entire deck is needed. Repairs should be made by a qualified general contractor.

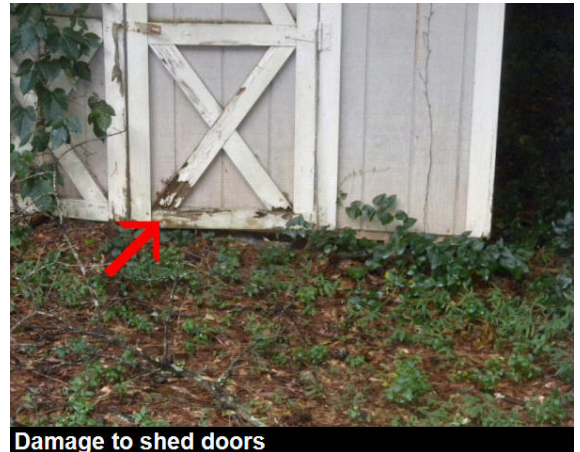
The rear shed doors have some rot/deterioration and should be repaired.

Damage to shed doors

2. The rear shed doors have some rot/deterioration and should be repaired.

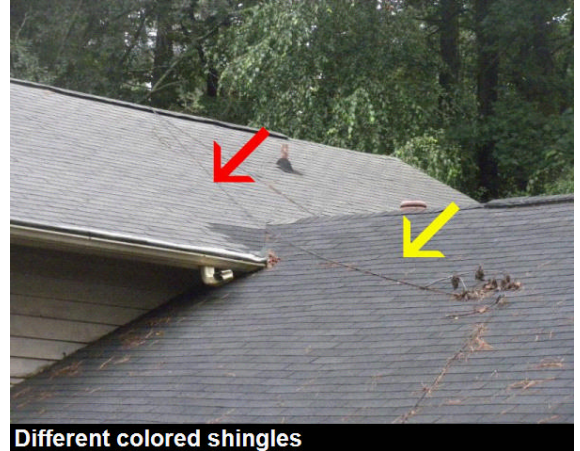
STYLE & PITCH:	Gable, High.
ROOFING TYPE:	Asphalt composition shingles.
ROOF ACCESS:	Walked on roof.
ROOF COVERING CONDITION:	The upper and lower roofs are two different color of shingles. Both of the roofs have been recently replaced.

Different colored shingles

4. The upper and lower roofs are two different color of shingles.

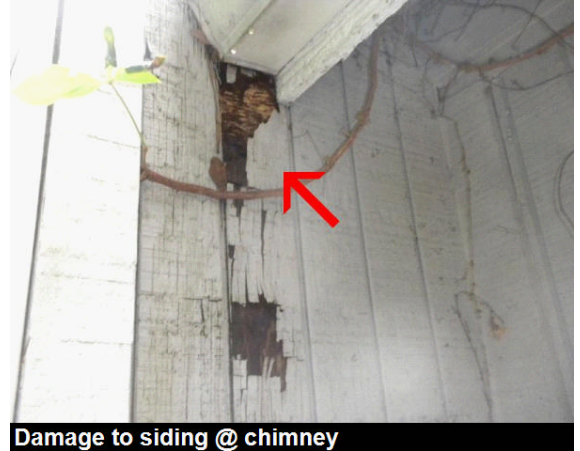
MATERIAL: Wood siding, Plywood.
CONDITION: Damaged siding was noted in the following location(s): sides of the chimney. Recommend further evaluation and repair as necessary by a qualified carpenter or general contractor.

Damage to siding @ chimney

5. Damaged siding was noted in the following location(s): sides of the chimney.

Recommend further evaluation and repair as necessary by a qualified carpenter or general contractor.

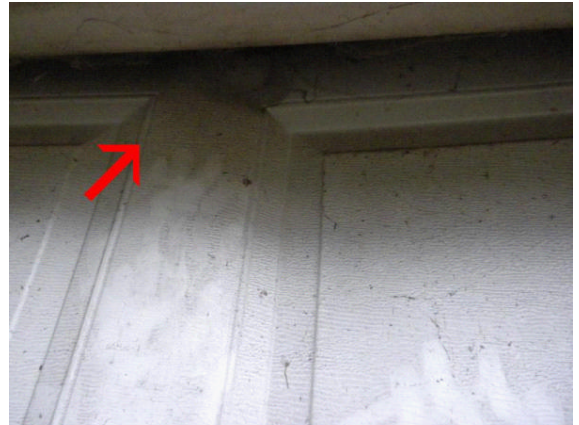
The top panel of the left garage door is damaged. The left garage door does not open/close properly. Both garage door openers are original to the house and are not working properly. These units are beyond their normal life expectancy. Replacement is recommended. Recommend further evaluation and repairs by a qualified overhead door contractor.

Damage to top panel of left side door

7. The top panel of the left garage door is damaged.

Recommend further evaluation and repairs by a qualified overhead door contractor.

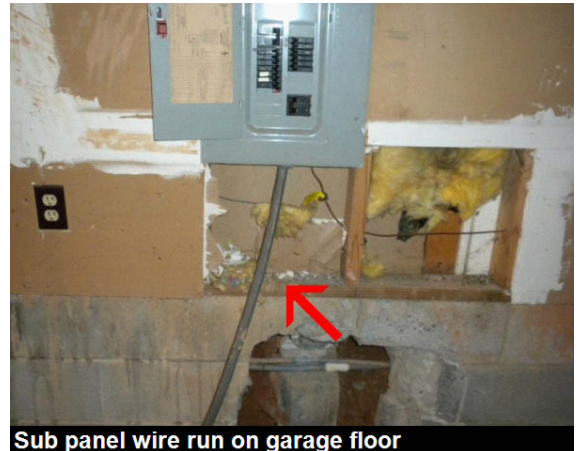
Sub panel wire run on garage floor

A sub panel has been run off the main panel. This sub panel wire has been run across the garage floor which is very dangerous. Consider removing the sub panel or having the sub panel properly installed.

Further evaluation and correction of all electrical problems as necessary by a qualified, licensed electrician is recommended.

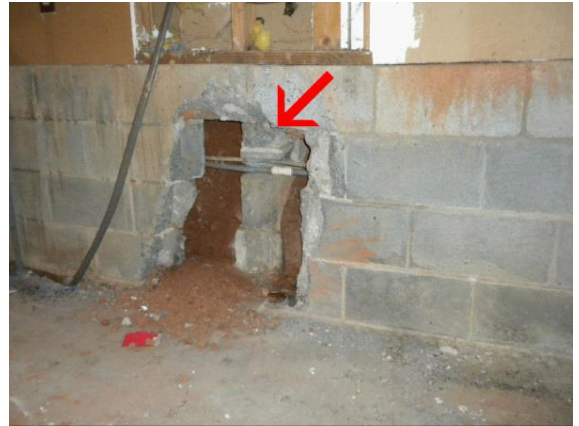
The block foundation wall has been broken/damaged under the electrical panel. Repairs should be made by a qualified contractor.

Damage to block wall under panel

9. The block foundation wall has been broken/damaged under the electrical panel. Repairs should be made by a qualified contractor.

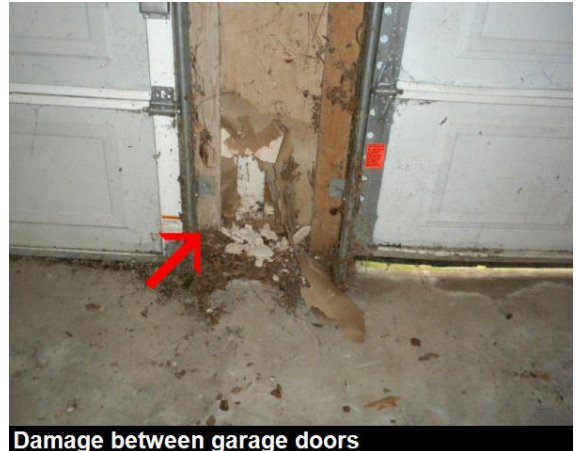
Evidence of a previous infestation by wood destroying insects was observed in the following location(s): between the garage doors at the front of the garage. Evidence of rodent activity was noted in the garage. Dead rodents were noted in the rear storage room of the garage. Further evaluation and treatment is recommended by a qualified pest control contractor.

Damage between garage doors

10. Evidence of a previous infestation by wood destroying insects was observed in the following location(s): between the garage doors at the front of the garage.

Further evaluation and treatment is recommended by a qualified pest control contractor.

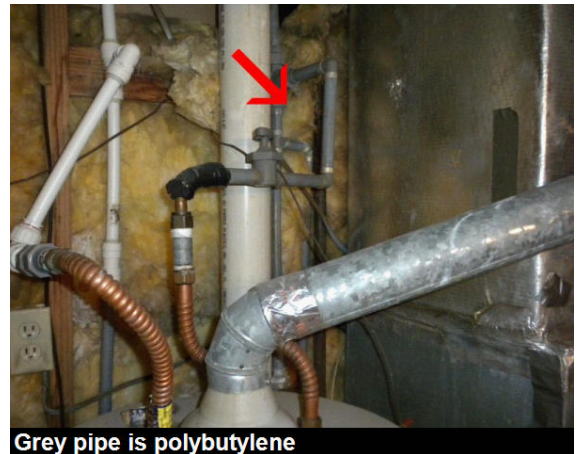
CONDITION: This material was involved in a class action lawsuit that has now expired. It is prone to failure. Consider having all the polybutylene replaced.

Grey pipe is polybutylene

12. This material was involved in a class action lawsuit that has now expired. It is prone to failure. Consider having all the polybutylene replaced.

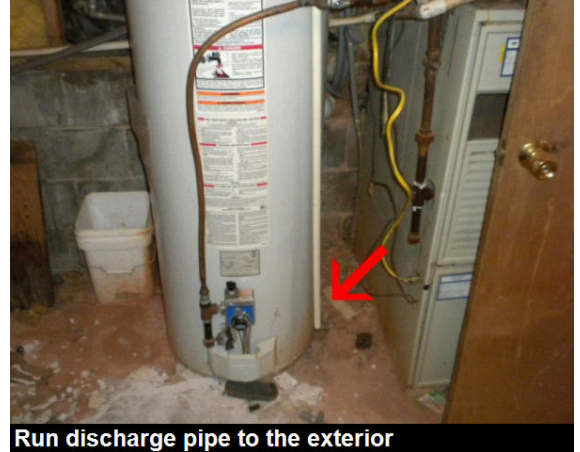
The discharge pipe on the temperature pressure relief valve (TPRV) discharges into the basement. Recommend running the discharge line to the exterior.

5. The discharge pipe on the temperature pressure relief valve (TPRV) discharges into the basement. Recommend running the discharge line to the exterior.

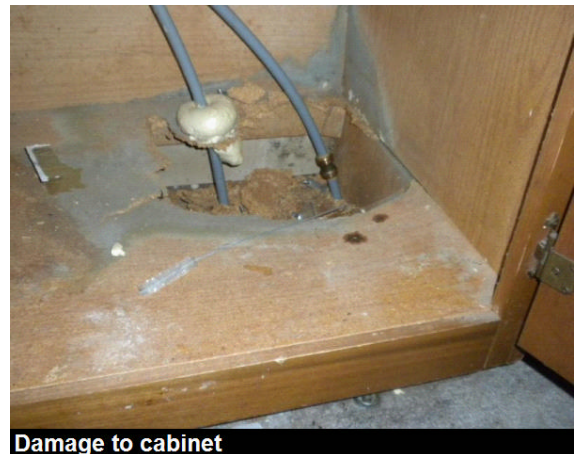
The master bathroom vanity cabinet is deteriorated/damaged. Replacement or repair of the cabinet is recommended.

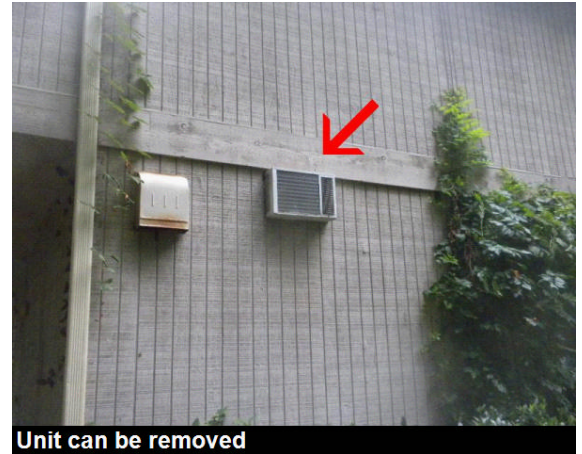
The window type air conditioner at the rear of the garage did not operate and can be removed.

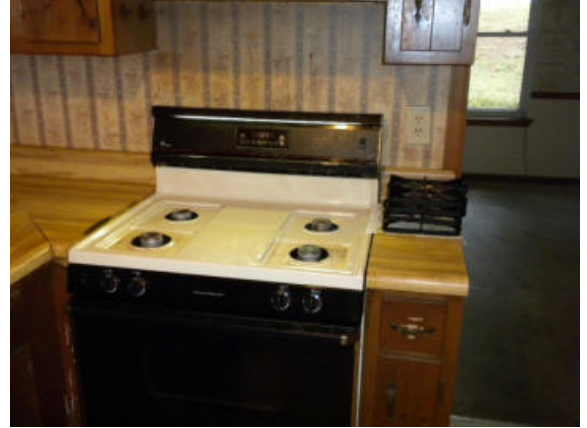
Gas. Older model unit that is in poor shape. Consider replacement.

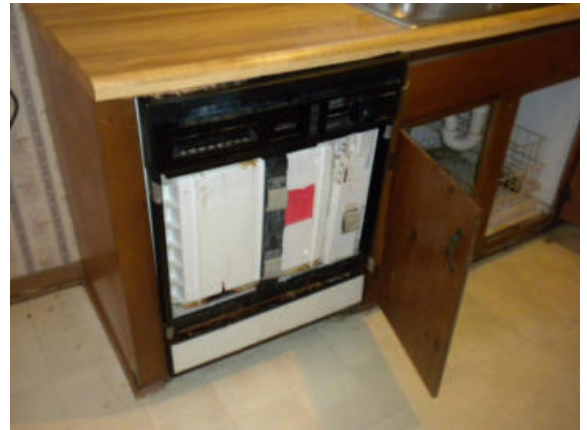
The front of the unit is missing. Replacement of the dishwasher is recommended.
