Inspection Report

Property Address:
2268 Ligney Creek Lane
Snellville, GA 30039

Date:
March 16, 2012

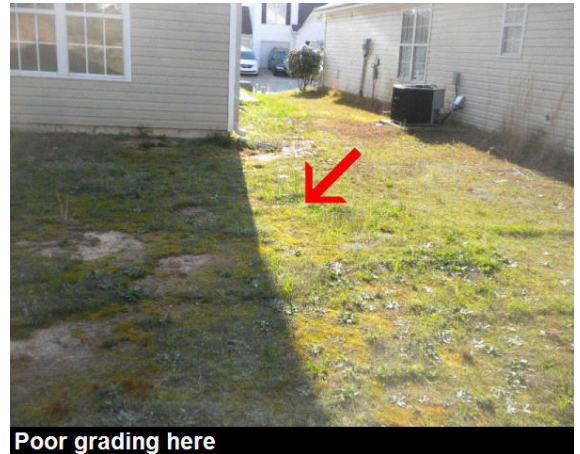
DESCRIPTION & CONDITION: Flat site, Grade(s) are not properly sloped away from the house in the following location(s): rear left corner of the lot. Moss growth was noted in this area indicating that water collects in this area. Recommend repairs be made by a qualified landscaping contractor.

1. Grade(s) are not properly sloped away from the house in the following location(s): rear left corner of the lot. Moss growth was noted in this area indicating that water collects in this area. Recommend repairs be made by a qualified landscaping contractor.

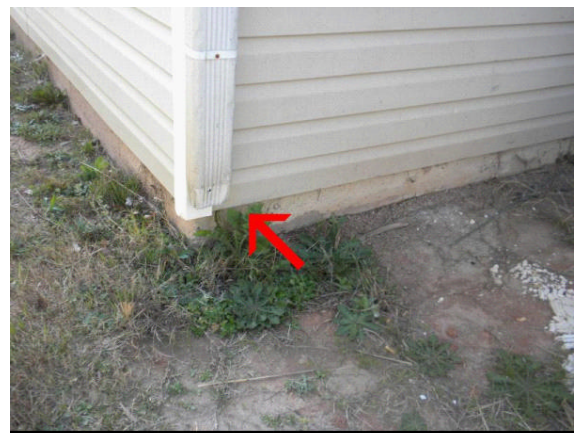
TYPE & CONDITION:	Metal. The rear right downspout is missing its bottom elbow. Replacing the missing elbow is recommended. Repairs should be made by a qualified contractor.
------------------------------	--

Elbow missing from downspout

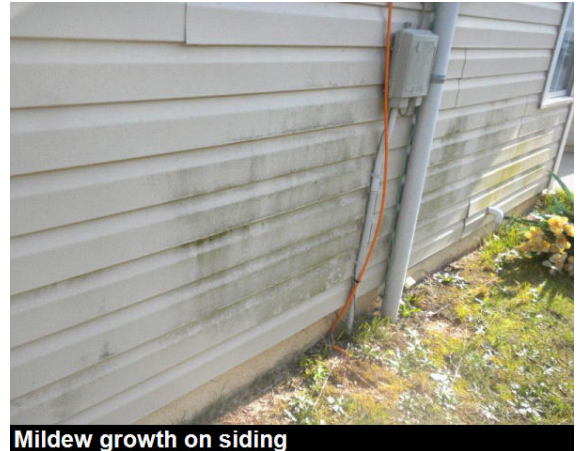
MATERIAL: Brick, Vinyl siding.
CONDITION: The vinyl siding has some mildew growth. Pressure washing the siding is recommended.

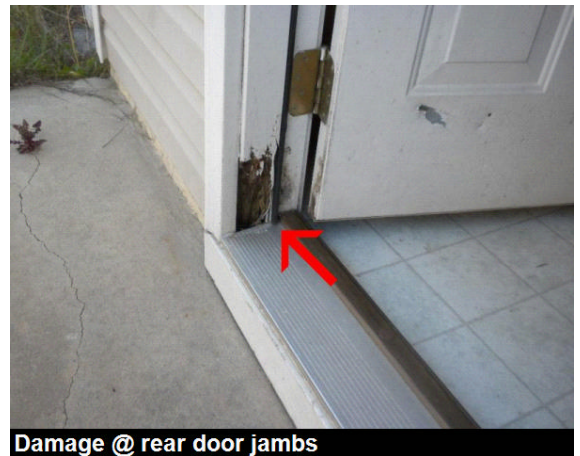
MATERIAL: Wood, Vinyl.
CONDITION: The rear entry door jambs are deteriorated. Condition(s) should be repaired/replaced as necessary by a qualified general contractor.

2. The rear entry door jambs are deteriorated. Condition(s) should be repaired/replaced as necessary by a qualified general contractor.

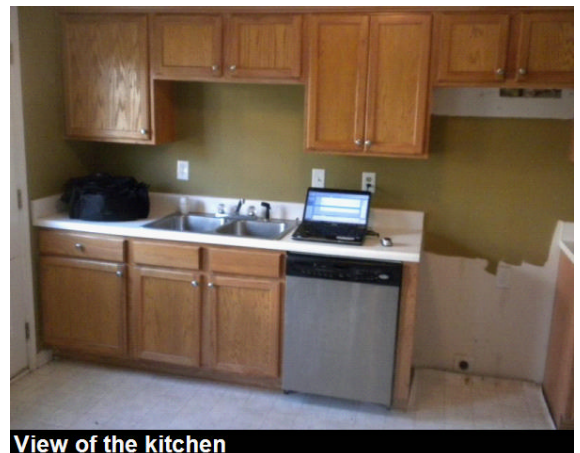
TYPE AND CONDITION: Wood, with minor wear.

View of the kitchen

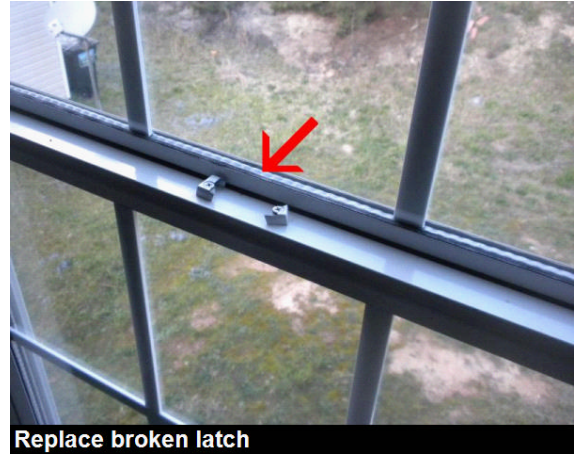
TYPE & CONDITION: Aluminum. The master bedroom left window has a broken latch. Replacing the latch is recommended.

Replace broken latch

5. The master bedroom left window has a broken latch. Replacing the latch is recommended.
