## Inspection Report

**Property Address:**  
3683 White Pine Road  
Snellville, GA 30039

**Date:**  
February 10, 2012

**Inspector:**  
Charles Mann  
Edifice Inspections, Inc.  
(770) 594-2222  
[www.edificeinspections.com](http://www.edificeinspections.com)

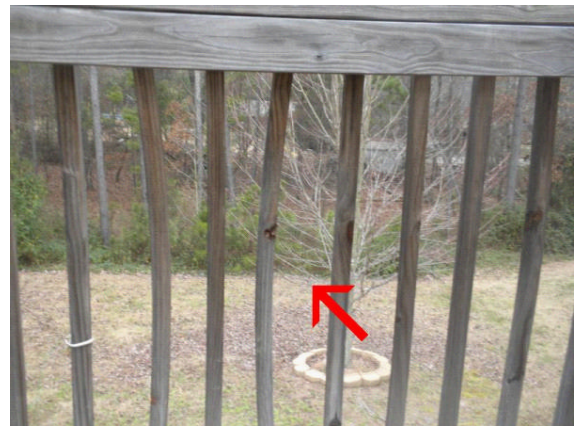
**TYPE:** Wood.  
**CONDITION:** Some of the railing pickets have warped and can be replaced.  
**The outer band is separated from the joist ends. Repairs should be made by a licensed general contractor.**

Warped railing pickets can be replaced

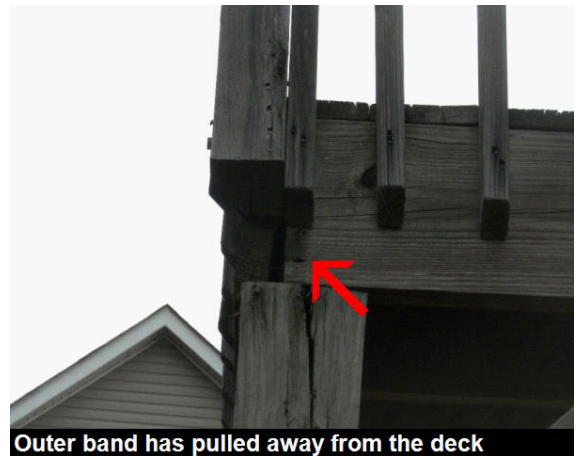
Outer band has pulled away from the deck

1. The outer band is separated from the joist ends.

Repairs should be made by a licensed general contractor.

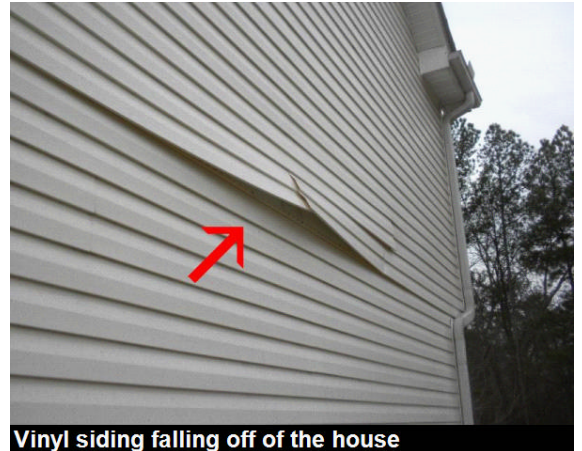
Vinyl siding falling off of the house

2. Some vinyl siding has become loose from the house at the right side. Re-installing the siding is recommended.

Recommend further evaluation and repair as necessary by a qualified carpenter or general contractor.

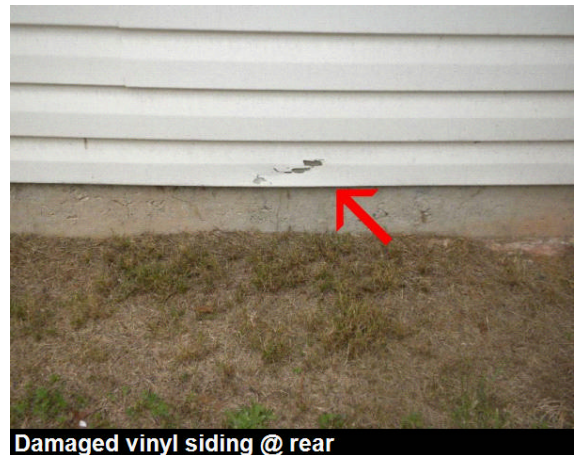
Damaged vinyl siding @ rear

Two pieces of damaged vinyl siding were noted at the rear of the house near the ground. These pieces can be replaced.

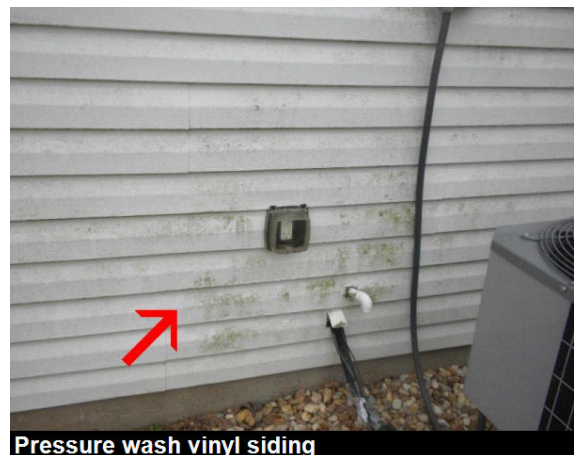
Pressure wash vinyl siding

Pressure washing the vinyl siding is recommended to remove mildew growth.

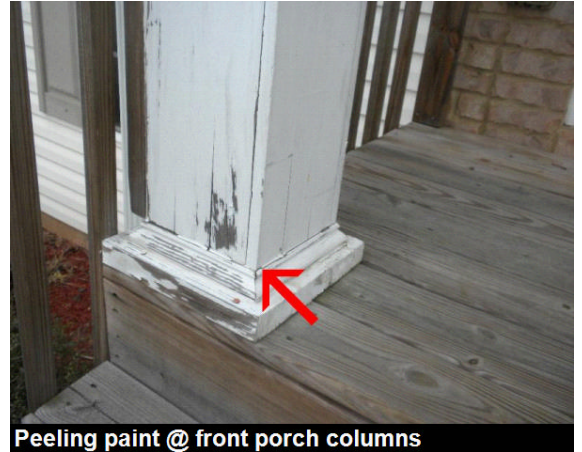
Peeling paint observed at the front porch columns and exterior door trims. Repainting the affected areas is recommended.

1. Peeling paint observed at the front porch columns and exterior door trims. Repainting the affected areas is recommended.

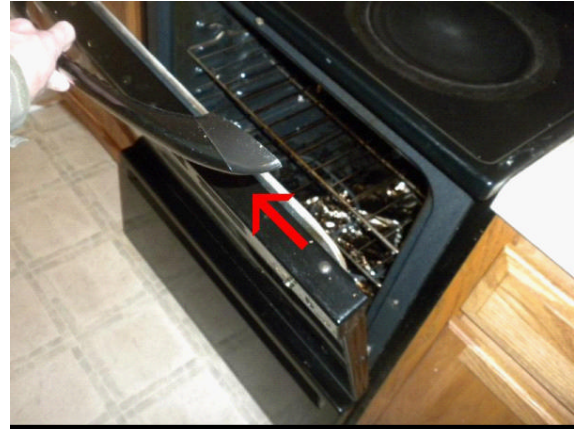
**TYPE/CONDITION:** Electric. The oven door handle is broken. Repairs can be made by a qualified appliance repair contractor.

Oven door handle is broken

4. The oven door handle is broken. Repairs can be made by a qualified appliance repair contractor.

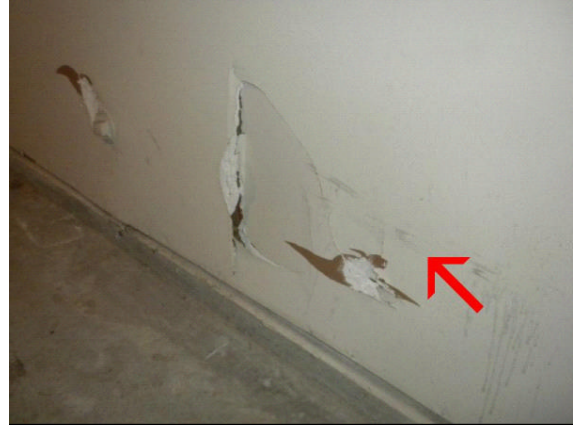
Drywall. Damaged drywall was noted at the garage. Repairs should be made by a qualified contractor.

Damaged drywall in the garage
