Inspection Report

Property Address:
1141 Sugar Maple Way
Lawrenceville, GA 30043

Date:
May 09, 2012

Inspector:
Charles Mann
Edifice Inspections, Inc.
(770) 594-2222
www.edificeinspections.com

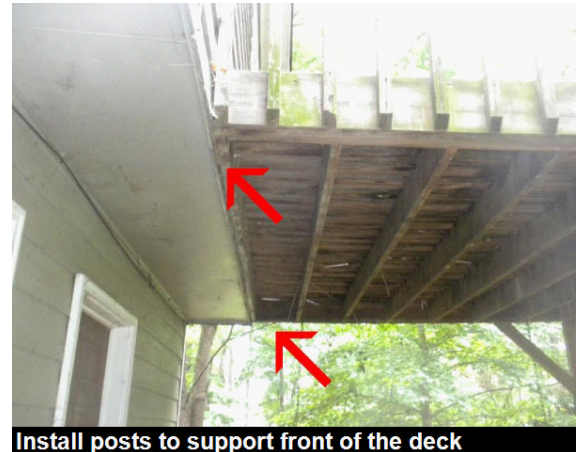
CONDITION: The deck joists are run parallel to the house which is not a preferred method of construction. The following items need to be corrected or repaired to make the deck safe: 4"x6" support posts should be installed at the front right and left corners of the deck (where the deck meets the house) to properly support the deck band, Excessive racking was noted. Installation of lateral bracing is recommended. The deck is not flashed at its connection to the house. Repairs should be made by a licensed general contractor.

1. The deck joists are run parallel to the house which is not a preferred method of construction. The following items need to be corrected or repaired to make the deck safe: 4"x6" support posts should be installed at the front right and left corners of the deck (where the deck meets the house) to properly support the deck band, Excessive racking was noted. Installation of lateral bracing is recommended. The deck is not flashed at its connection to the house. Repairs should be made by a licensed general contractor.

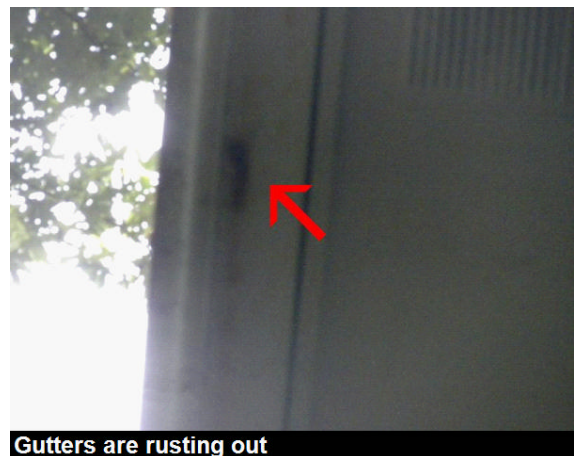
TYPE & CONDITION:	Metal, Rusting viewed in the following location(s): left side of the house. The gutters are near the end of their useful life. Replacement of all of the gutters should be expected in the next few years. Repairs should be made by a qualified contractor.
------------------------------	--

Gutters are rusting out

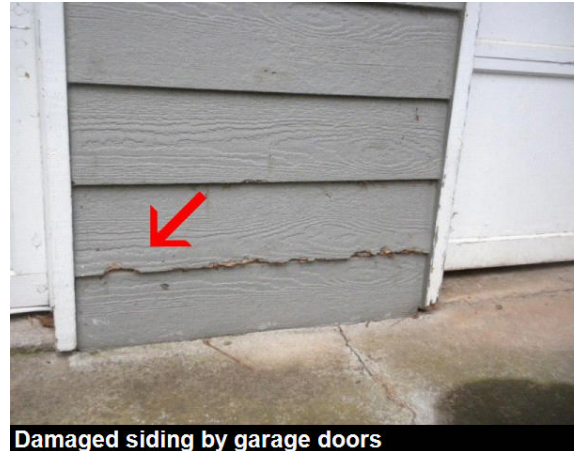
Damaged/decayed siding was noted in the following location(s): front of the house between the garage doors, right side of the house above the ground, left side of the house, chimney, rear of the house near the A/C unit. Replacing the affected pieces of siding with similar fiber cement siding is recommended. Recommend further evaluation and repair as necessary by a licensed general contractor.

Damaged siding by garage doors

2. Damaged/decayed siding was noted in the following location(s): front of the house between the garage doors, right side of the house above the ground, left side of the house, chimney, rear of the house near the A/C unit. Replacing the affected pieces of siding with similar fiber cement siding is recommended. Recommend further evaluation and repair as necessary by a licensed general contractor.

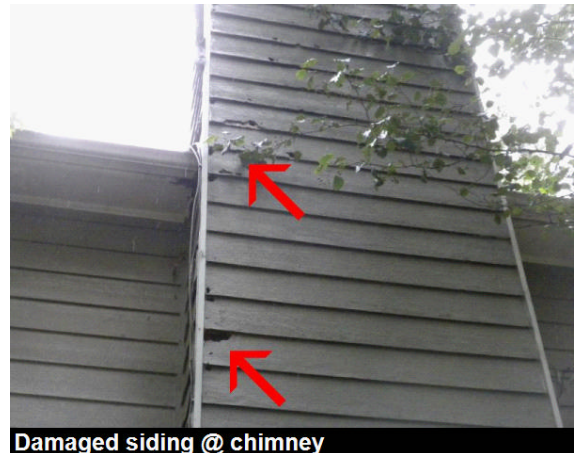
Damaged siding @ chimney

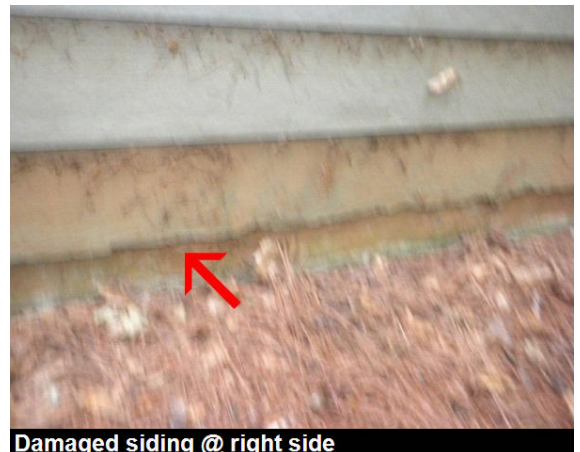
Damaged siding @ right side

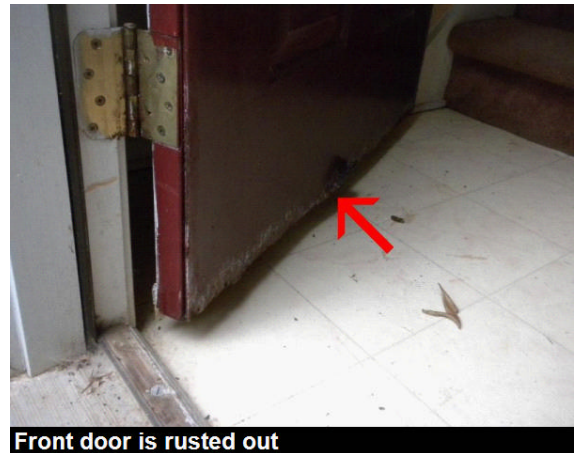
The front entry door is rusted out at its bottom. Replacing the door is recommended. Condition(s) should be repaired by a licensed general contractor.

Front door is rusted out

3. The front entry door is rusted out at its bottom. Replacing the door is recommended. Condition(s) should be repaired by a licensed general contractor.

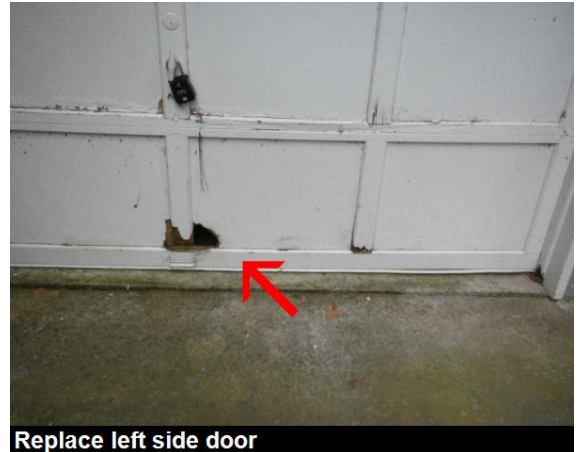
The left side door is deteriorated and should be replaced.
Recommend further evaluation and repairs by a qualified overhead door contractor.

Replace left side door

4. The left side door is deteriorated and should be replaced. Recommend further evaluation and repairs by a qualified overhead door contractor.

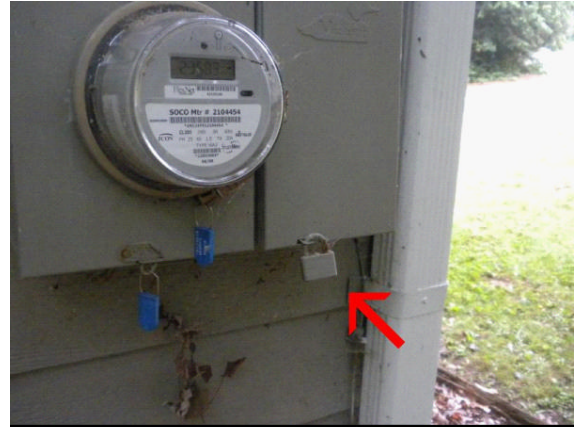
TYPE AND CONDITION:	Overhead, Enters the front of the house, Acceptable.
MATERIAL:	Aluminum.
AMPERAGE:	Amperage rating not determined- A pad lock was installed on the service disconnect. Removing this pad lock is recommended for safety.

Pad lock should be removed

5. Amperage rating not determined- A pad lock was installed on the service disconnect. Removing this pad lock is recommended for safety.

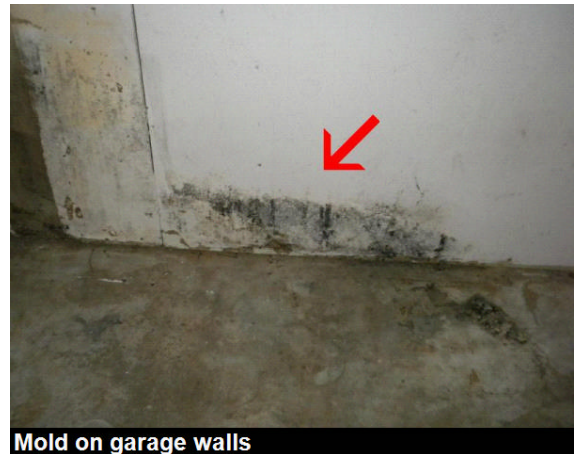
Suspected mold/mildew was observed in the following locations: garage walls. See www.epa.gov/mold for more information. Repairs should be made by a qualified contractor.

Mold on garage walls

8. Suspected mold/mildew was observed in the following locations: garage walls. See www.epa.gov/mold for more information. Repairs should be made by a qualified contractor.

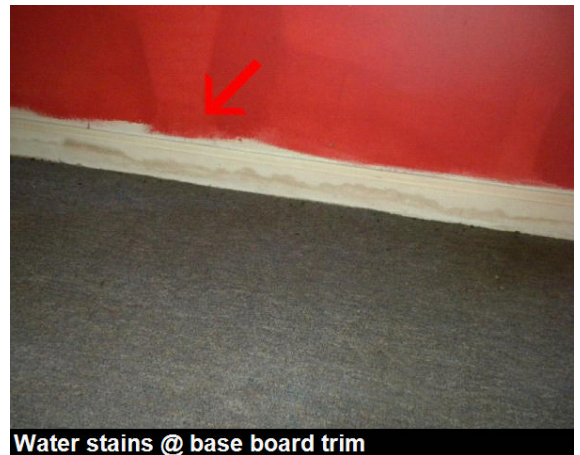
Evidence of previous water penetration was noted at the front left basement finished room. Staining was noted on the base board trim. These areas were dry at the time of the inspection.

Water stains @ base board trim

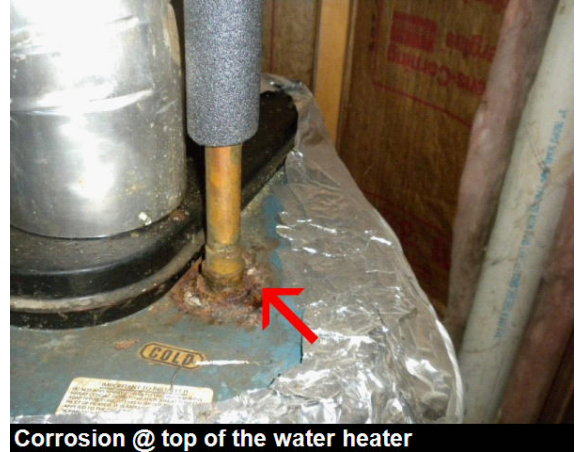
Some rusting/corrosion was noted at the top of the water heater. The water heater is near the end of its life expectancy. Replacement should be budgeted for.

Corrosion @ top of the water heater

The water heater is near the end of its life expectancy. Replacement should be budgeted for.

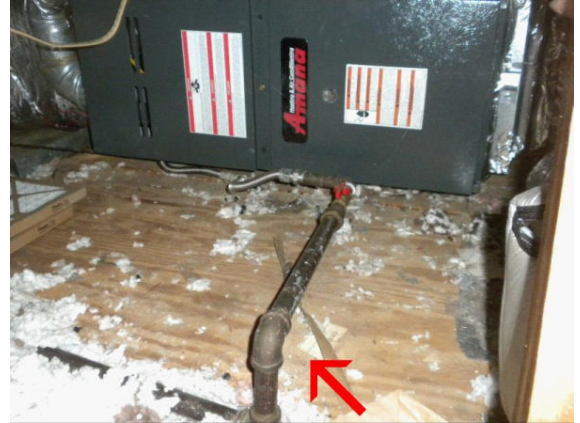
FUEL TYPE & CONDITION: Natural Gas, No drip leg is installed on the gas line at the furnace.
Repairs should be made by a qualified, licensed HVAC contractor.

No drip leg on the gas line

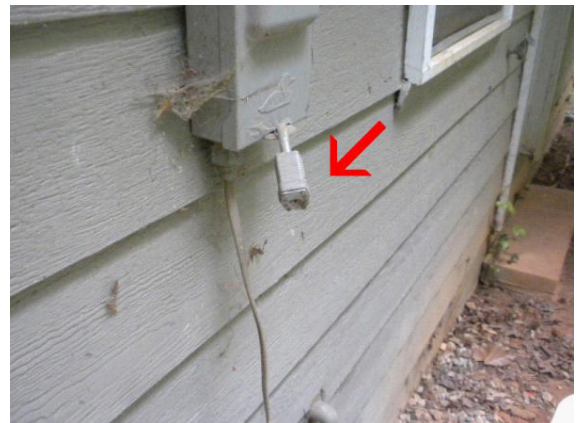
POWER SOURCE: Electric, 240 Volt. **A pad lock was installed on the service disconnect for the A/C unit. The romex wire between the service disconnect and the A/C unit does not have a conduit. Removing the pad lock and installing a conduit is recommended. Repairs can be made by a qualified contractor.**

Remove pad lock & install conduit

12. A pad lock was installed on the service disconnect for the A/C unit. The romex wire between the service disconnect and the A/C unit does not have a conduit. Removing the pad lock and installing a conduit is recommended. Repairs can be made by a qualified contractor.

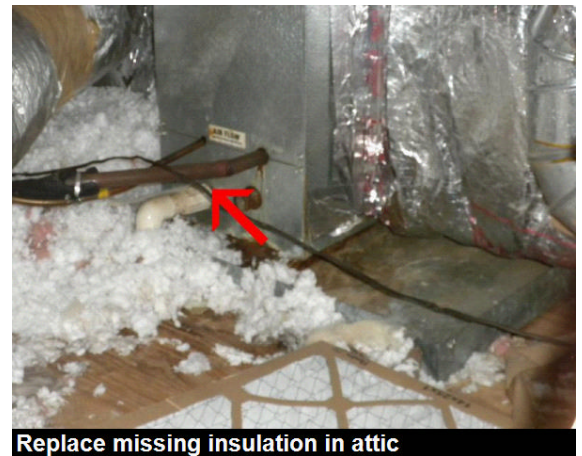
CONDENSATE LINES:	Condensate line installed.
NORMAL CONTROLS:	Acceptable.
MANUFACTURER:	Bryant.
APPROXIMATE AGE IN YEARS:	22.
APPROX. CAPACITY IN TONS:	2
CONDITION:	The insulation on the large refrigerant line between the compressor and the exterior wall and in the attic near the A coil is worn/missing and should be replaced.

3. The insulation on the large refrigerant line between the compressor and the exterior wall and in the attic near the A coil is worn/missing and should be replaced.

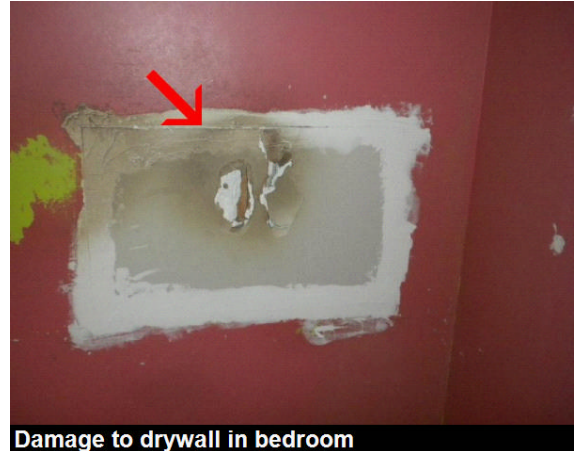
MATERIAL & CONDITION: Drywall. Damage was noted in several areas. Repairs should be made before painting.
