## Inspection Report

**Property Address:**  
3660 Scotland Lane  
Snellville, GA 30039

**Date:**  
May 02, 2012

**Inspector:**  
Charles Mann  
Edifice Inspections, Inc.  
(770) 594-2222  
[www.edificeinspections.com](http://www.edificeinspections.com)

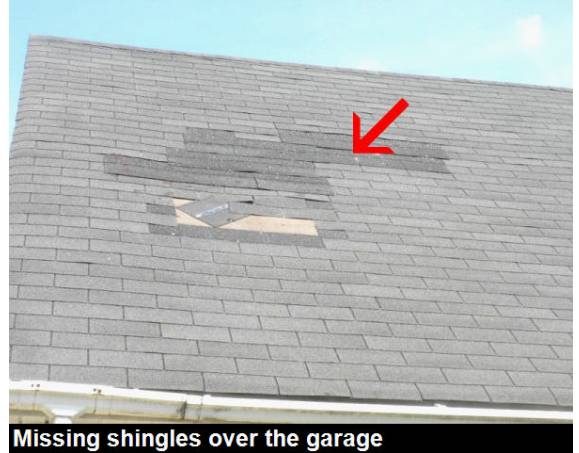
| <b>ROOF COVERING CONDITION:</b> | <b>Missing shingles were noted over the right side of the garage. Condition(s) should be further evaluated and repaired as necessary by a qualified roofing contractor.</b> |

1. Missing shingles were noted over the right side of the garage.

Condition(s) should be further evaluated and repaired as necessary by a qualified roofing contractor.

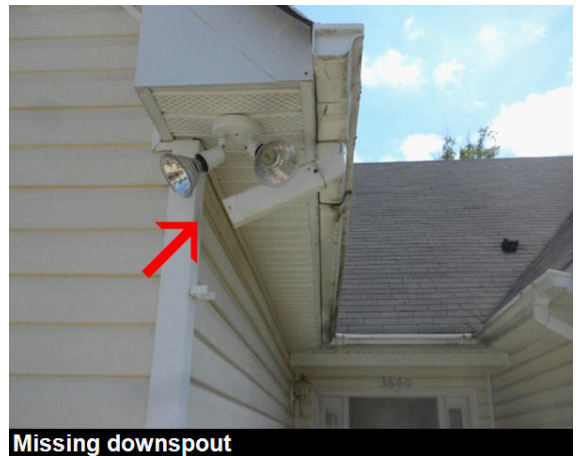
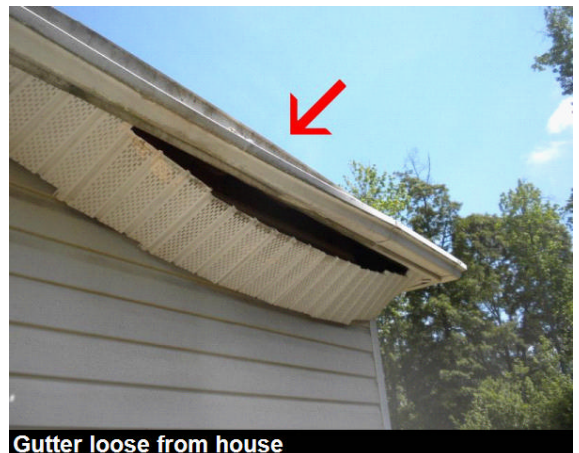
| <b>TYPE &amp; CONDITION:</b> | <p>Metal. The front downspout right of the garage has fallen off of the house. Re-installing the downspout is recommended.</p> <p>The gutter at the right side of the house is loose.</p> <p>The rear gutter has fallen off of the house. A large portion of this section of gutter is missing.</p> <p>Repairs should be made by a qualified contractor.</p> |

1. The front downspout right of the garage has fallen off of the house. Re-installing the downspout is recommended.

The gutter at the right side of the house is loose.

Repairs should be made by a qualified contractor.

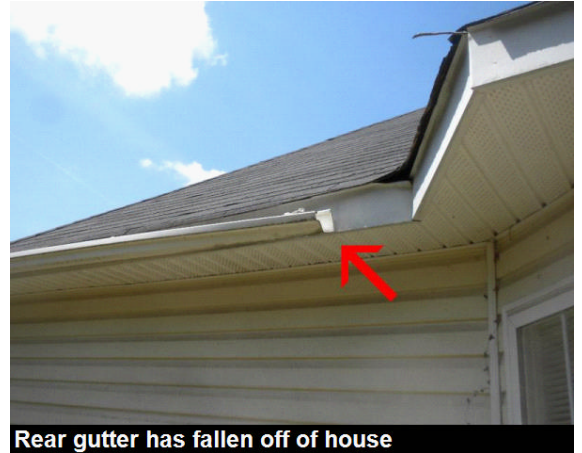
Rear gutter has fallen off of house

The rear gutter has fallen off of the house. A large portion of this section of gutter is missing.

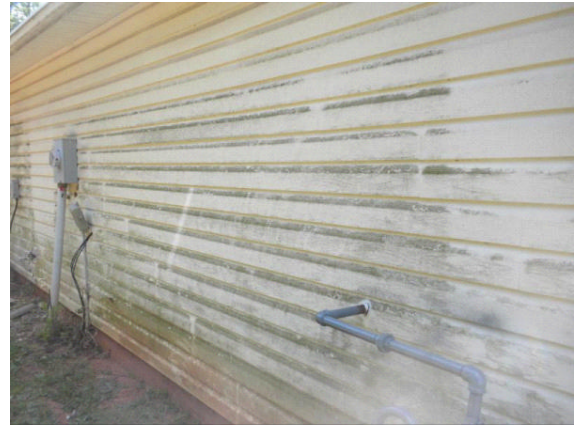
Mildew growth was noted on the vinyl siding. Pressure washing the siding is recommended.

Pressure wash siding

2. Mildew growth was noted on the vinyl siding. Pressure washing the siding is recommended.

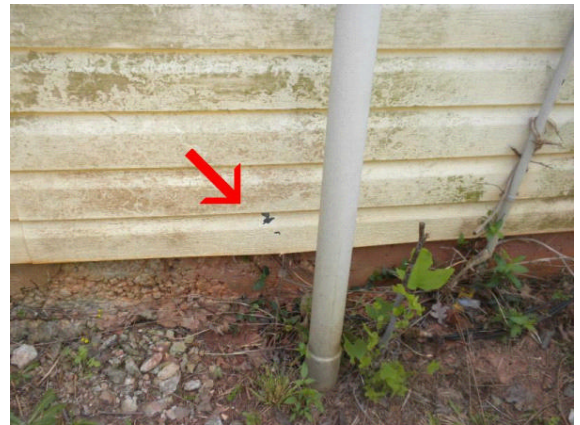
Damaged/decayed siding was noted in the following location(s): left, right and rear sides of the house near the ground. Replacing the damaged pieces of siding is recommended.

Damaged to siding @ left side

Damaged/decayed siding was noted in the following location(s): left, right and rear sides of the house near the ground.

Replacing the damaged pieces of siding is recommended.

Recommend further evaluation and repair as necessary by a licensed general contractor.

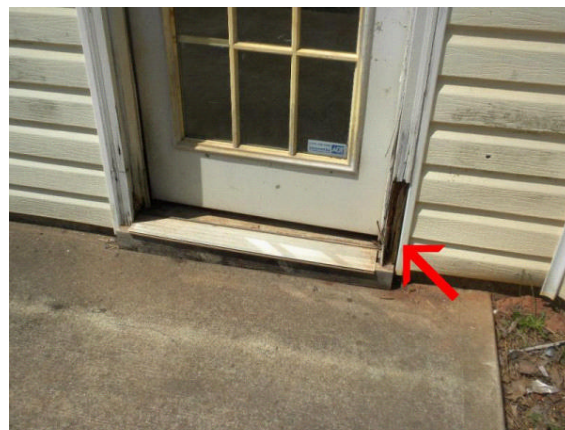
Damage/decay noted in the following location(s): frame at the rear entry door. Condition(s) should be repaired/replaced as necessary by a licensed general contractor.

Damage @ rear entry door

The frame for the rear entry door will need to be repaired.

4. Damage/decay noted in the following location(s): frame at the rear entry door.

Condition(s) should be repaired/replaced as necessary by a licensed general contractor.

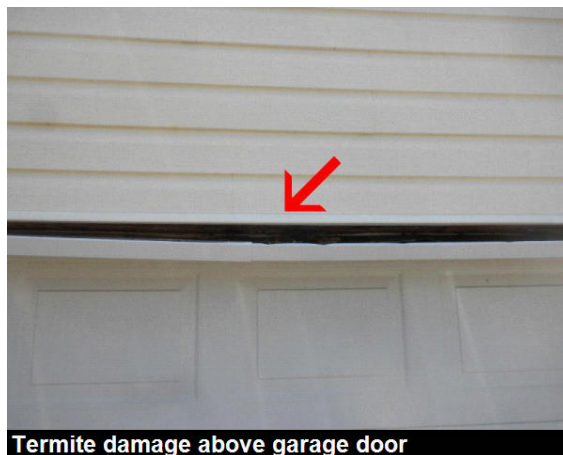
Termite damage was noted to the trim and framing above and left and right of the garage door. Further evaluation is recommended by a qualified pest control contractor. Repairs should be made by a licensed general contractor.

Termite damage above garage door

5. Termite damage was noted to the trim and framing above and left and right of the garage door. Further evaluation is recommended by a qualified pest control contractor. Repairs should be made by a licensed general contractor.

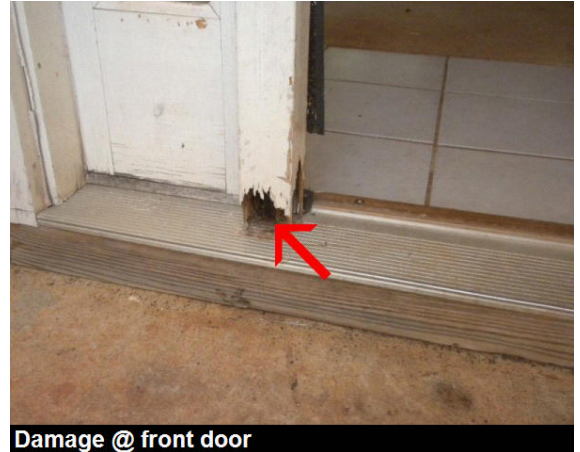
An active infestation by wood destroying insects was observed in the following location(s): rear entry door frame, front entry door frame, rear master bedroom window, master bedroom front wall, hall bathroom near commode, front bedroom window sills, front wall of garage, above garage door.

Damage @ front door

6. An active infestation by wood destroying insects was observed in the following location(s): rear entry door frame, front entry door frame, rear master bedroom window, master bedroom front wall, hall bathroom near commode, front bedroom window sills, front wall of garage, above garage door.

Further evaluation and treatment is recommended by a qualified pest control contractor.

Some additional framing damage may be present under the drywall. Repairs should be made by a licensed general contractor.

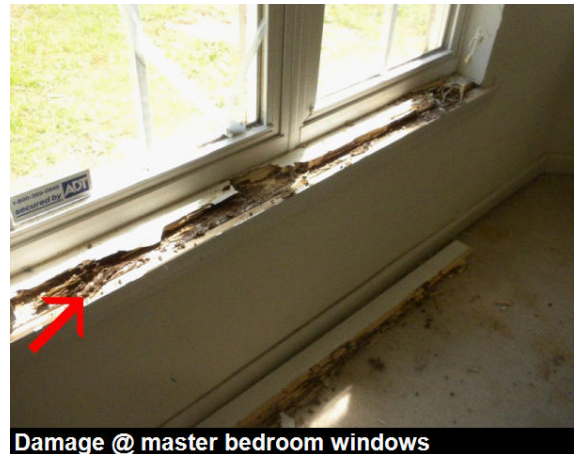
Damage @ master bedroom windows

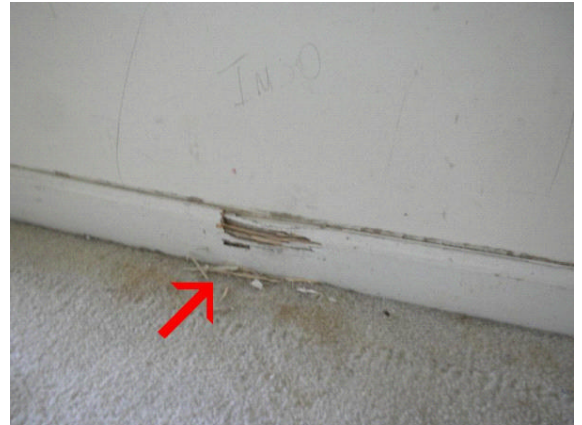
**Damage @ master bedroom wall**

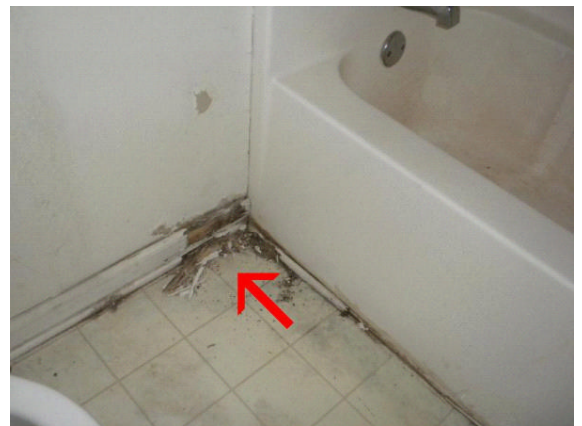
**Damage @ hall bathroom**

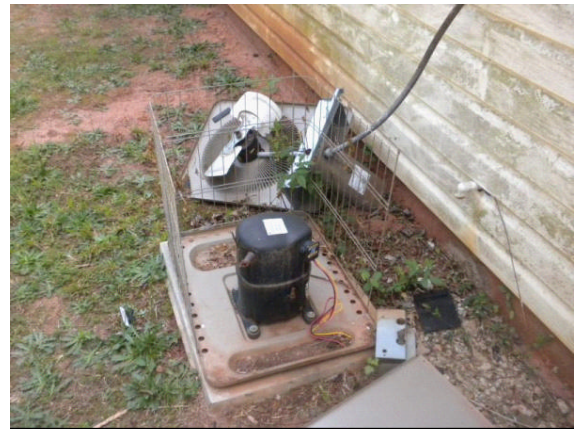
**SYSTEM TYPE:** The unit has been stolen.  
Replacing the A/C unit is needed.

Unit has been stolen

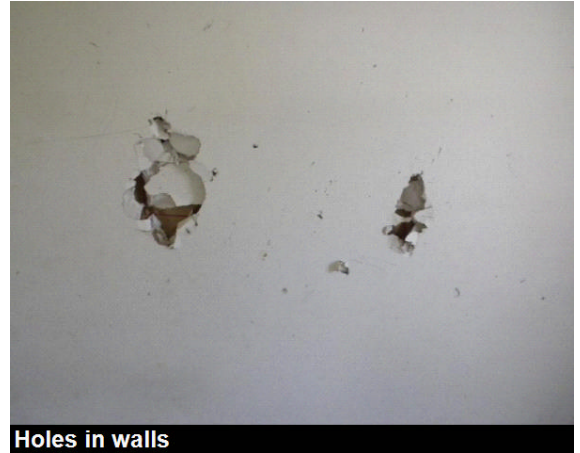
Drywall. Several holes/damage was noted to the walls. Repairs should be made by a qualified contractor.

Holes in walls
