## Inspection Report

**Property Address:**  
1551 Wynfield Drive  
Auburn, GA 30011

**Date:**  
July 09, 2012

**Inspector:**  
Charles Mann  
Edifice Inspections, Inc.  
(770) 594-2222  
[www.edificeinspections.com](http://www.edificeinspections.com)

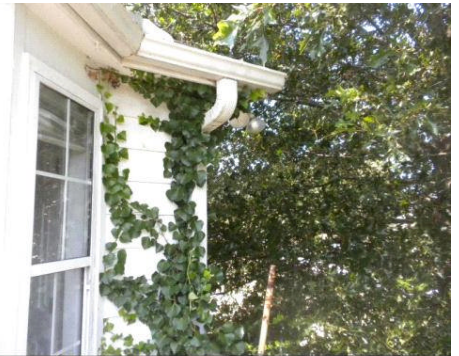
**Condition:** There are trees/bushes in contact with the building. Trimming of all trees/bushes away from the building is recommended to avoid damage to siding, trim or roofing.

**Trim all trees/bushes away from house**

1. There are trees/bushes in contact with the building. Trimming of all trees/bushes away from the building is recommended to avoid damage to siding, trim or roofing.

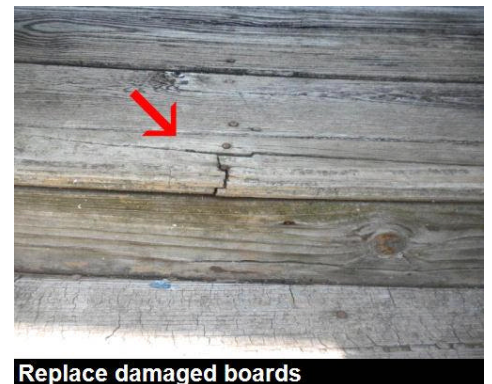
**Description:** Wood.  
**Condition:** The railings are loose at the front deck. Re-securing the railings is recommended. Some of the front deck surface boards are cracked/broken. Replacing the damaged surface boards is recommended. Recommend repairs be made by a licensed general contractor.

**Replace damaged boards**

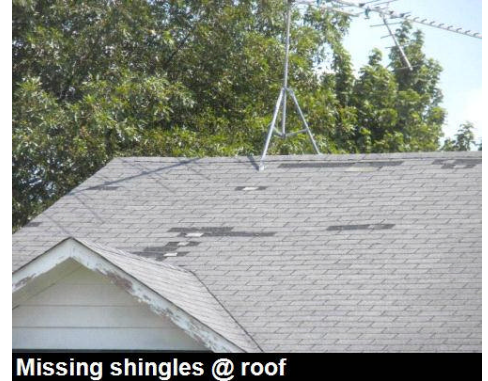
<b>Style &amp; Pitch:</b>	Gable, High.
<b>Roofing Type:</b>	Asphalt composition shingles.
<b>Roof Access:</b>	Viewed from ground with binoculars.
<b>Roof Condition:</b>	<b>Significant granule erosion was observed. This is indicative of roofing nearing the end of its useful life.</b> <b>Several shingles were damaged and/or missing. Due to conditions observed replacement of the entire roof is recommended.</b>

2. Significant granule erosion was observed. This is indicative of roofing nearing the end of its useful life. Several shingles were damaged and/or missing. Due to conditions observed replacement of the entire roof is recommended.

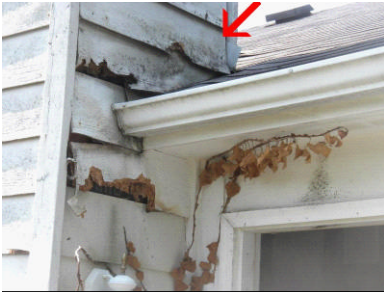
**Condition:** Damaged/decayed siding was noted in the following location(s): front, left, right, rear sides of the house. Siding at the chimney chase.  
All damaged siding should be replaced with a matching fiber cement siding product.  
Recommend further evaluation and repair as necessary by a licensed general contractor.

Damage @ chimney chase

3. Damaged/decayed siding was noted in the following location(s): front, left, right, rear sides of the house. Siding at the chimney chase. All damaged siding should be replaced with a matching fiber cement siding product. Recommend further evaluation and repair as necessary by a licensed general contractor.

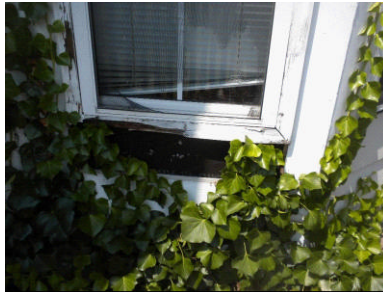
Missing siding @ front

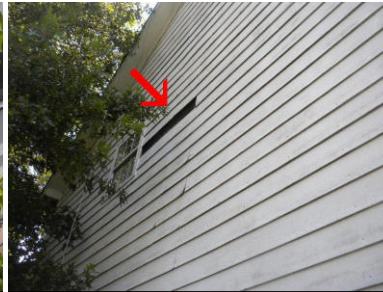
Missing siding @ left

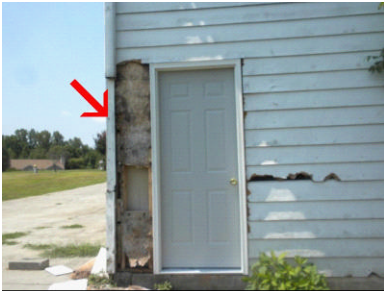
Missing siding @ garage

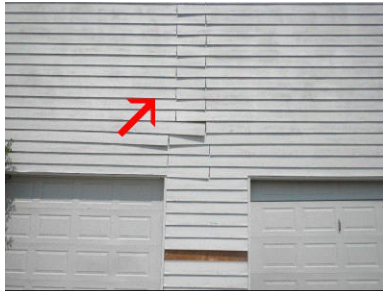
Damaged siding @ right

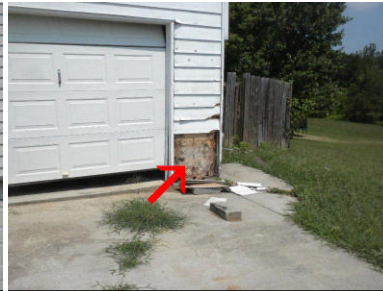
Missing siding @ right

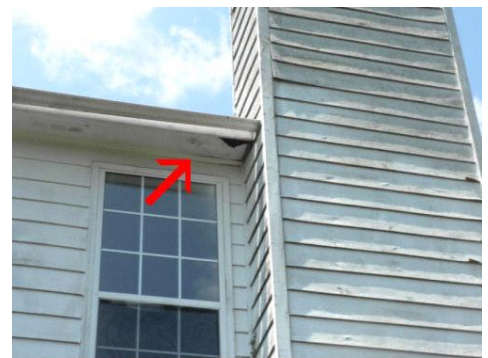
**Condition:** Damage/decay was noted in the following location(s): rear of the house near the chimney. Recommend repairs be made by a licensed general contractor.

Damaged soffit @ rear

4. Damage/decay was noted in the following location(s): rear of the house near the chimney. Recommend repairs be made by a licensed general contractor.

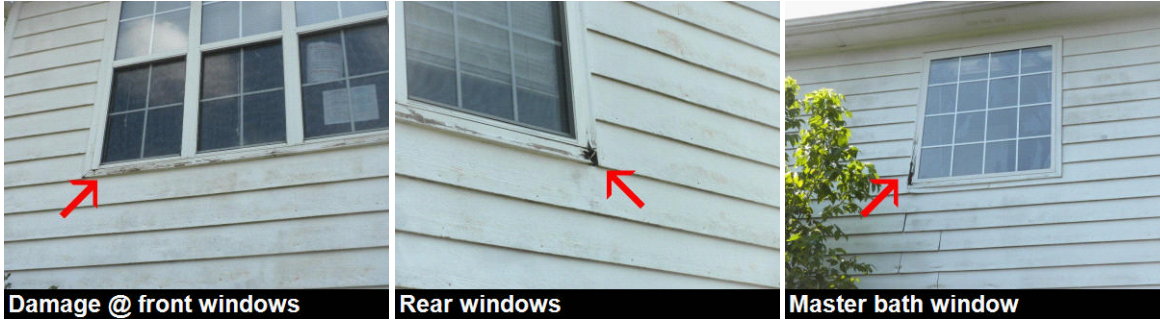
**Condition:** Damage/decay noted in the following location(s): front entry door jambs and trim, rear right corner of the garage, window trims at rear windows, window trims at front lower level windows.  
Condition(s) should be repaired/replaced as necessary by a licensed general contractor.

5. Damage/decay noted in the following location(s): front entry door jambs and trim, rear right corner of the garage, window trims at rear windows, window trims at front lower level windows. Condition(s) should be repaired/replaced as necessary by a licensed general contractor.

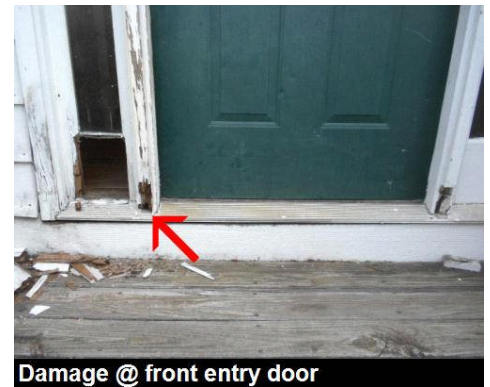
The front entry door sidelights are deteriorated. Replacing the front entry door frame is recommended.

6. The front entry door sidelights are deteriorated. Replacing the front entry door frame is recommended.

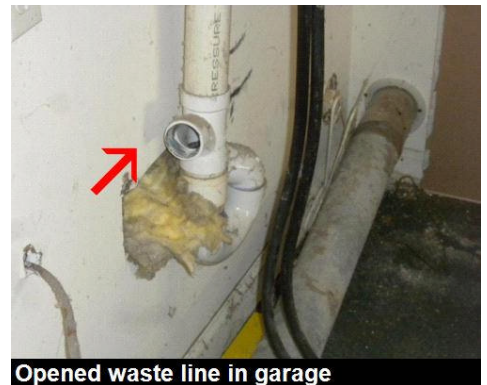
**CONDITION:** Open waste line was noted at the garage laundry room drain pipe. Condition(s) should be repaired by a qualified, licensed plumber.

8. Open waste line was noted at the garage laundry room drain pipe.  
Condition(s) should be repaired by a qualified, licensed plumber.

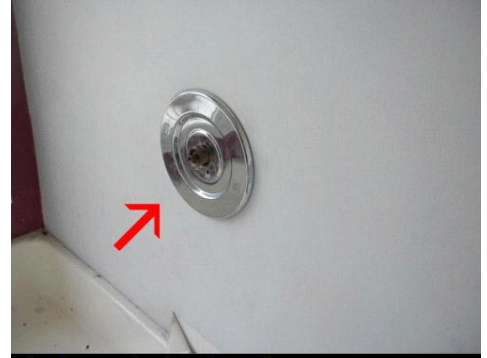
**BATHTUBS:** The master bathroom tub faucet handle is missing.  
Condition(s) should be repaired by a qualified, licensed plumber.

Replace missing handle

2. The master bathroom tub faucet handle is missing.

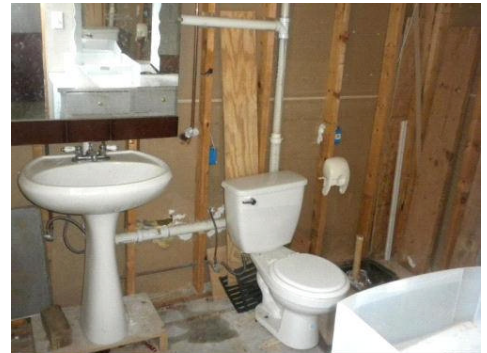
The lower level bathroom is partially finished. The bathroom fixtures are unprofessionally installed. Repairs can be made by a qualified, licensed general contractor. Adding a bathtub and properly installed the sink, commode and electrical fixtures is needed to have a proper third bathroom.

Redo lower level bathroom

10. The lower level bathroom is partially finished. The bathroom fixtures are unprofessionally installed. Repairs can be made by a qualified, licensed general contractor. Adding a bathtub and properly installed the sink, commode and electrical fixtures is needed to have a proper third bathroom.

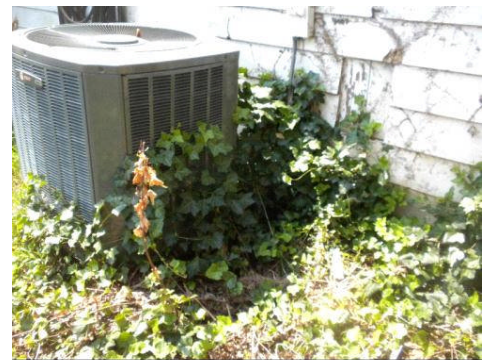
**CONDITION:** Unit is not producing an adequate air temperature drop. The unit only produced approximately a 15 degree temperature drop. Shrubbery is too close to condensing unit, trimming is recommended. Further evaluation and repair or replacement by a qualified HVAC contractor is recommended.

Trim bushes away from A/C unit

11. Unit is not producing an adequate air temperature drop. The unit only produced approximately a 15 degree temperature drop.  
Shrubbery is too close to condensing unit, trimming is recommended.  
Further evaluation and repair or replacement by a qualified HVAC contractor is recommended.

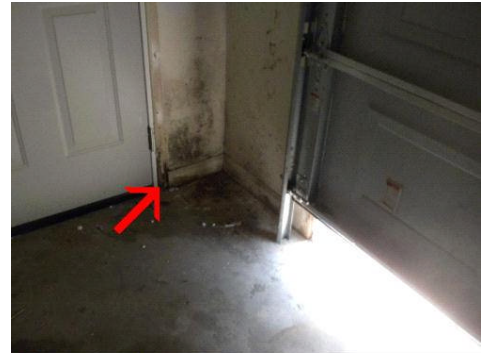
Drywall. Some minor damage was noted. The lower level unfinished drywall has mold growth on its surface. Some mold growth was noted at the garage drywall near the doors. Removal all affected drywall on the lower level is recommended. See [www.epa.gov/mold](http://www.epa.gov/mold) for more information. Repairs can be made by a qualified contractor.

Mold growth in garage

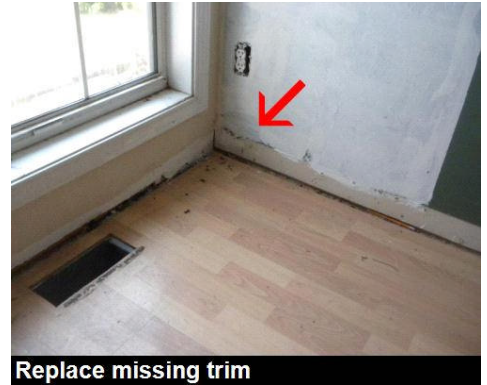
Missing base trim was noted in the family room and part of the hallway. Replacing the missing trim is recommended.
