## Inspection Report

**Property Address:**  
3131 Water Brook Drive  
Conyers, GA 30094

**Date:**  
October 18, 2012

**Inspector:**  
Charles Mann  
Edifice Inspections, Inc.  
(770) 594-2222  
[www.edificeinspections.com](http://www.edificeinspections.com)

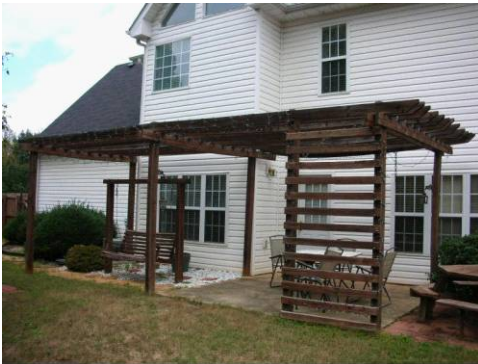
**Type:** Concrete.  
**Condition:** A wood trellis has been constructed over the patio. This structure should be repaired or removed.

Remove or repair structure

1. A wood trellis has been constructed over the patio. This structure should be repaired or removed.

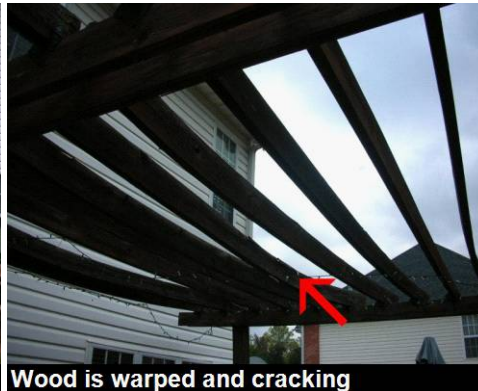
Wood is warped and cracking

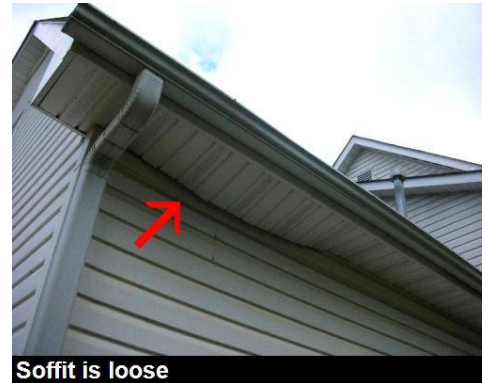
**Condition:** Some of the soffit is loose from the house near the rear right corner.  
Recommend repairs be made by a licensed general contractor.

1. Some of the soffit is loose from the house near the rear right corner.  
Recommend repairs be made by a licensed general contractor.

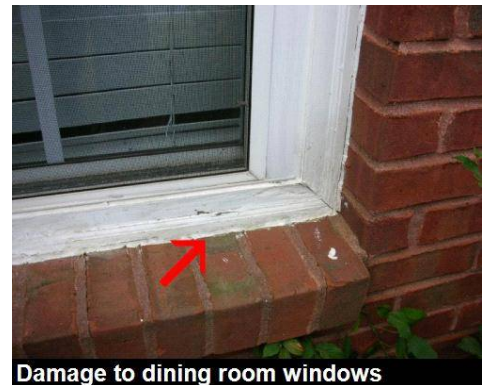
**Condition:** Damage/decay noted in the following location(s):  
wood trim at the front dining room windows.  
Trim is loose from above the garage door.  
Re-attaching the trim is recommended.  
Condition(s) should be repaired/replaced as necessary by a licensed general contractor.

2. Damage/decay noted in the following location(s): wood trim at the front dining room windows.  
Condition(s) should be repaired/replaced as necessary by a licensed general contractor.

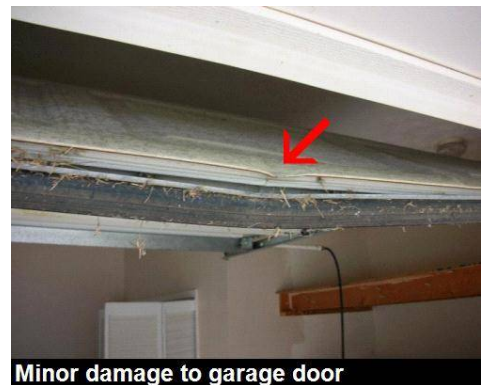
Minor damage was noted at the bottom panel of the garage door. The door is functional.

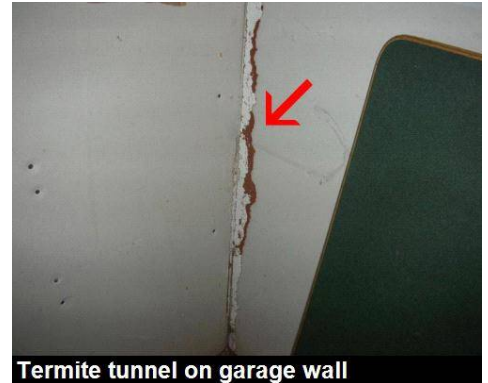
**Condition:** An active infestation by wood destroying insects was observed in the following location(s): rear garage wall including the area near the furnace and water heater. Further evaluation and treatment is recommended by a qualified pest control contractor.

Termite tunnel on garage wall

3. An active infestation by wood destroying insects was observed in the following location(s): rear garage wall including the area near the furnace and water heater.  
Further evaluation and treatment is recommended by a qualified pest control contractor.

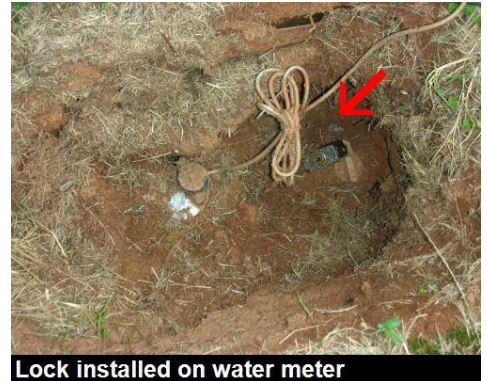
**Condition:** The water meter was off at the time of the inspection. A lock was installed on the meter valve.

Lock installed on water meter

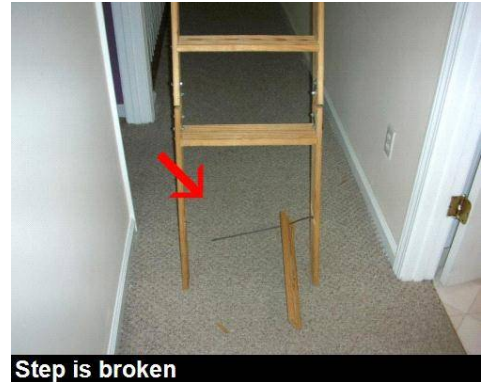
**Condition:** The bottom step of the pull down stairs is broken.  
Repairs should be made by a qualified contractor.

2. The bottom step of the pull down stairs is broken. Repairs should be made by a qualified contractor.
