Inspection Report

Property Address:
1223 Dressage Ridge NE
Conyers, GA 30013

Date:
October 09, 2012

Inspector:
Charles Mann
Edifice Inspections, Inc.
(770) 594-2222
www.edificeinspections.com

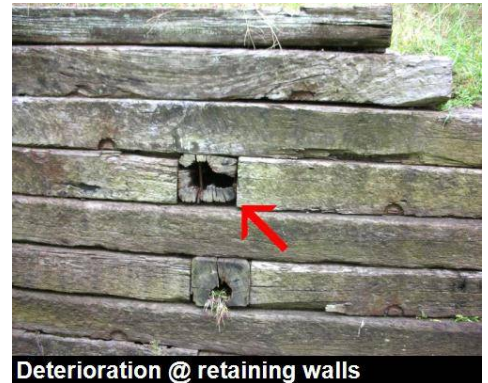
Type: Railroad tie.
Condition: Some deterioration was noted to the railroad tie retaining walls. These walls will need to be replaced in the next 5 to 7 years.

Deterioration @ retaining walls

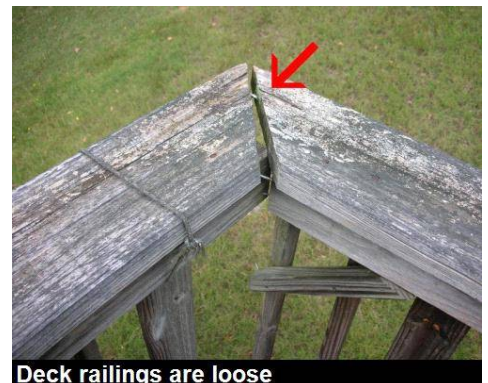
Type: Wood.
Condition: The deck railings are loose and falling off the deck. Re-securing the railings is recommended. Several of the nails are loose from the deck surface boards. Re-securing these nails is recommended. Repairs should be made by a licensed general contractor.

Deck railings are loose

1. The deck railings are loose and falling off the deck. Re-securing the railings is recommended. Several of the nails are loose from the deck surface boards. Re-securing these nails is recommended. Repairs should be made by a licensed general contractor.

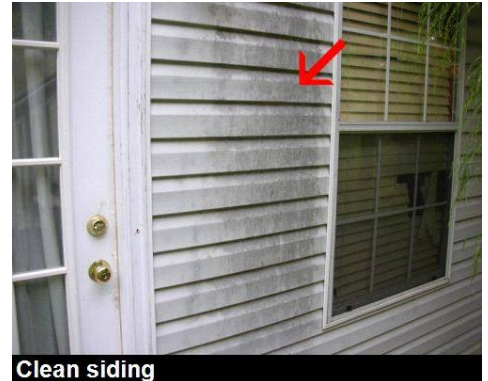
Condition: Mildew growth was noted on the vinyl siding. Cleaning or pressure washing the siding is recommended.

Clean siding

2. Mildew growth was noted on the vinyl siding. Cleaning or pressure washing the siding is recommended.

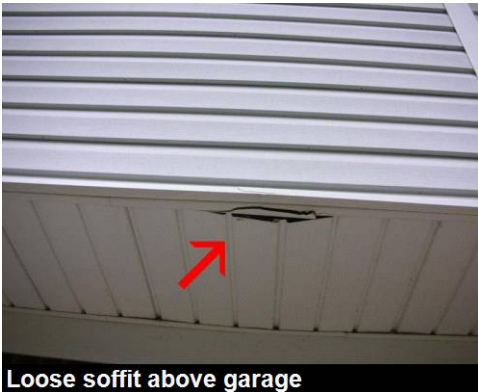
Condition: The soffit is loose in the following locations: front of the house above the garage, right side of the house.
Recommend repairs be made by a licensed general contractor.

Loose soffit above garage

3. The soffit is loose in the following locations: front of the house above the garage, right side of the house. Recommend repairs be made by a licensed general contractor.

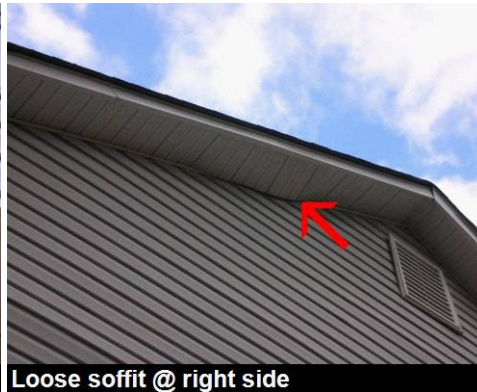
Loose soffit @ right side

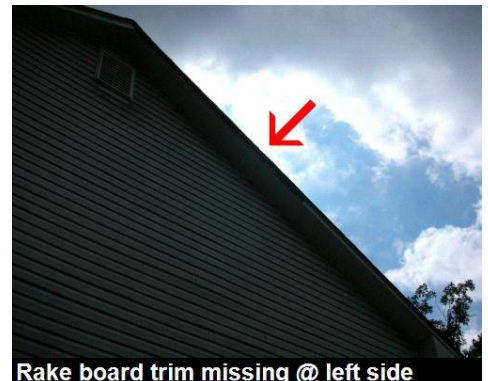
Condition: The rake board trim is missing at the left side of the house.
Condition(s) should be repaired/replaced as necessary by a licensed general contractor.

Rake board trim missing @ left side

2. The rake board trim is missing at the left side of the house. Condition(s) should be repaired/replaced as necessary by a licensed general contractor.

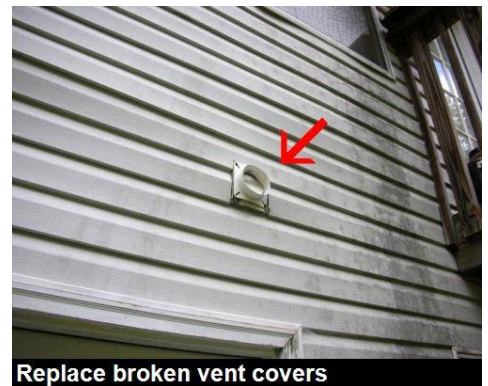
A broken vent cover was noted at the rear and a second broken vent cover was noted at the left side of the house. Replacing these vent covers is recommended. Repairs should be made by a licensed general contractor.

5. A broken vent cover was noted at the rear and a second broken vent cover was noted at the left side of the house.
Replacing these vent covers is recommended.
Repairs should be made by a licensed general contractor.
